Summary report
Mohammed Batterjee's Heritage Building Restoration
Prof Adnan Adas

بيت السيد محمد مازن البترجي

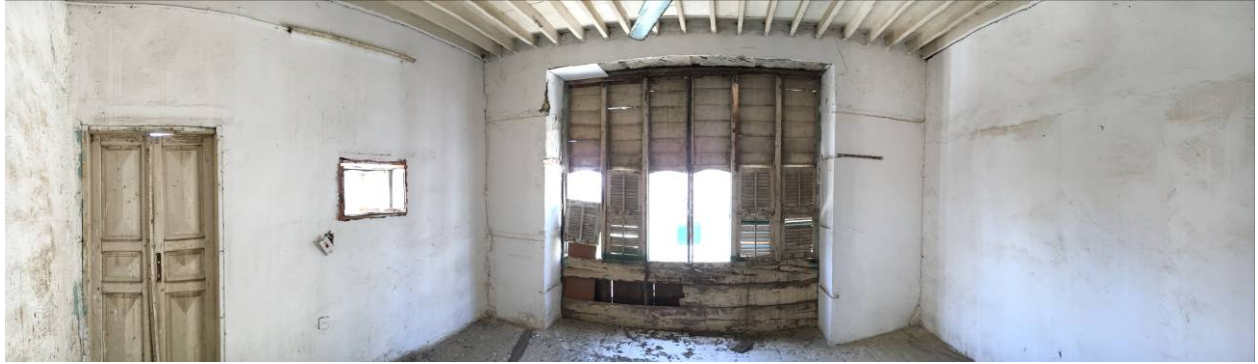
- General recommendations

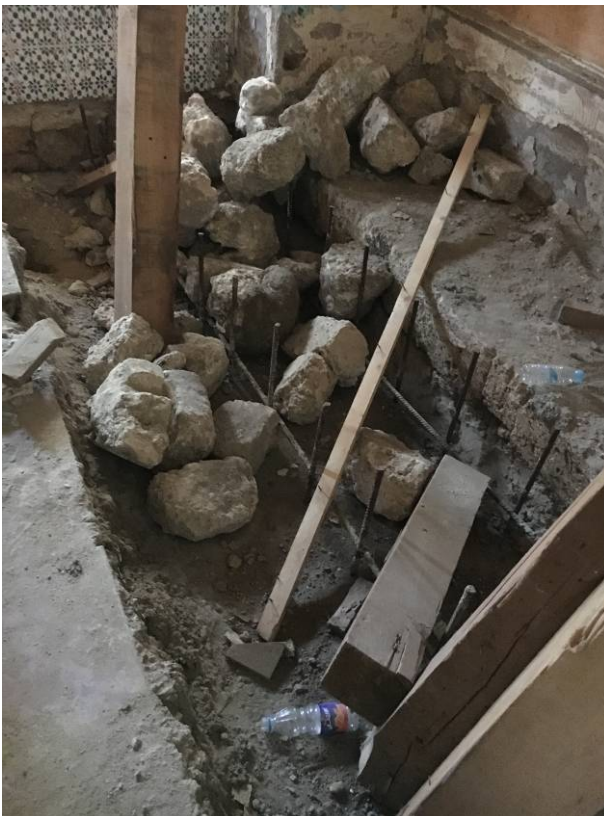
Foundation consolidation (steel-frame concrete)

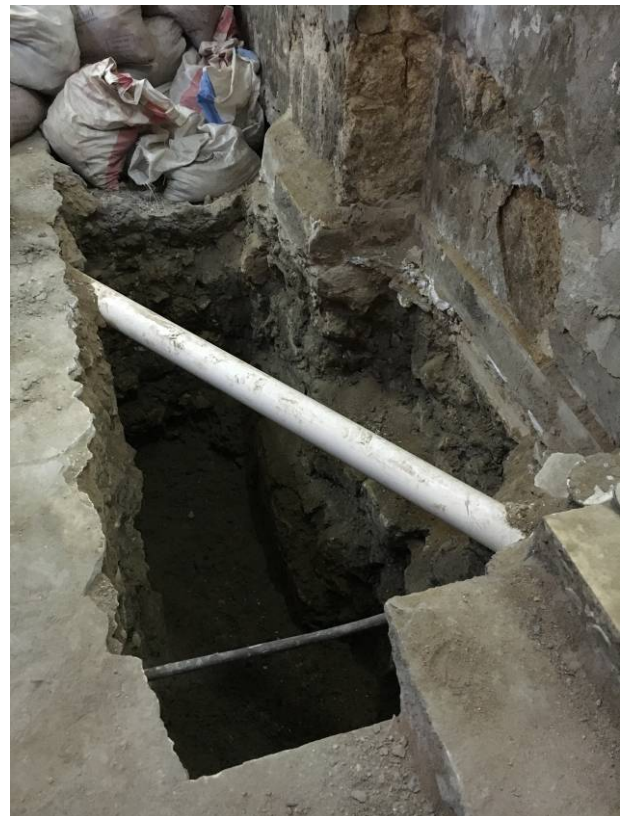
Ground level - Soil, pipes and water table level...

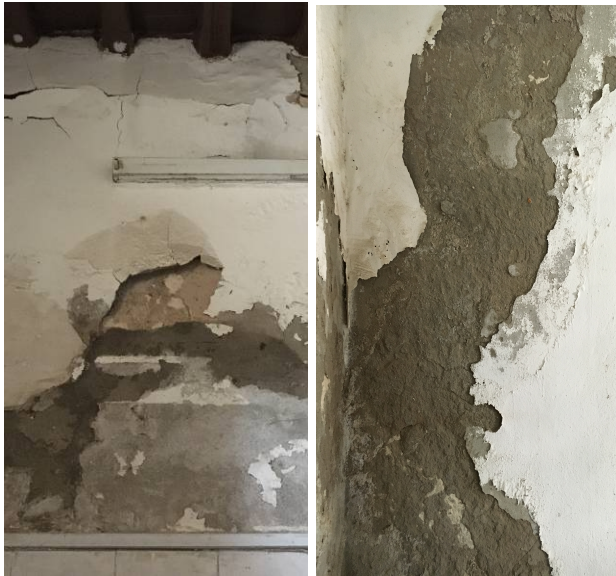
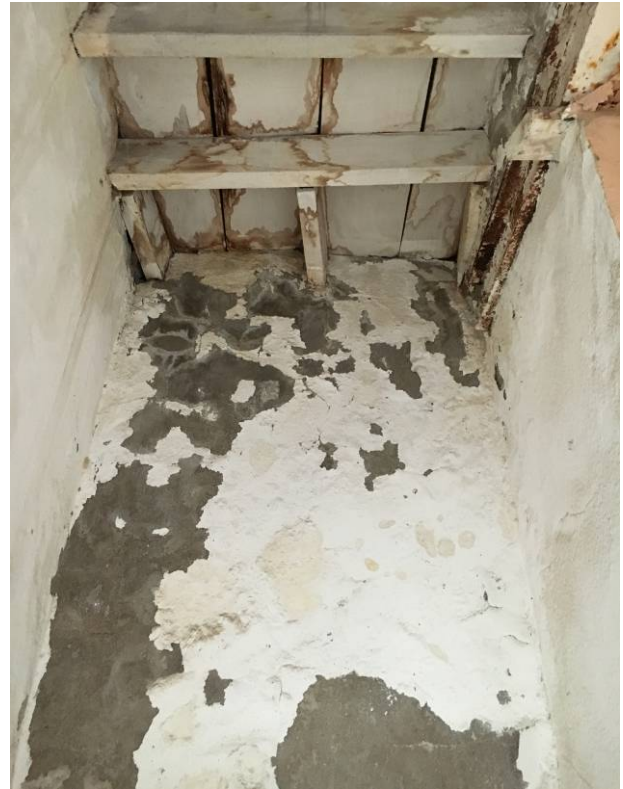
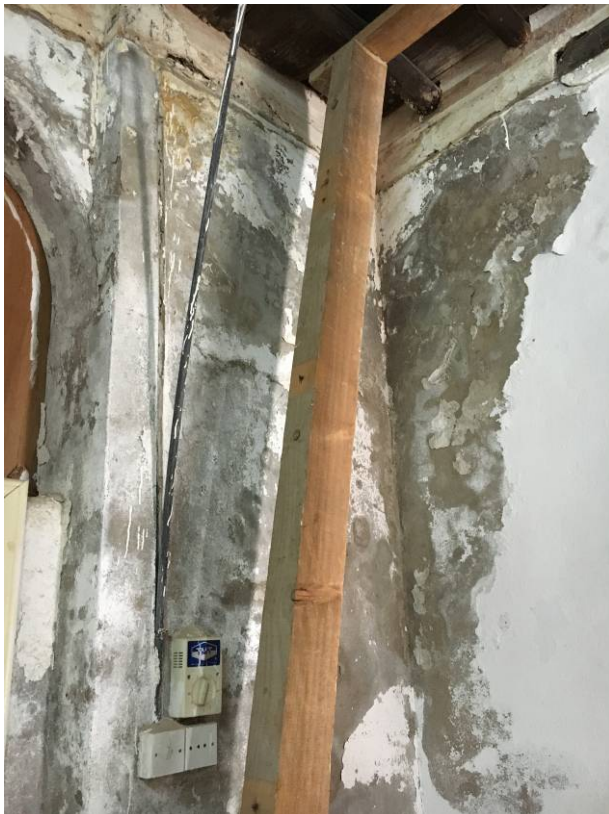
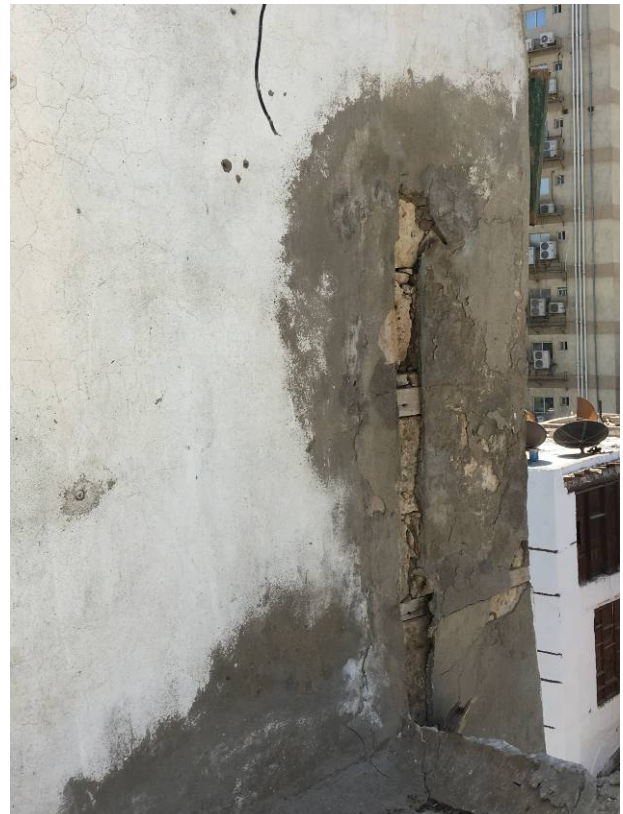
Cement layers and associated pathologies - to be removed, walls dried and repaired, then re-plastered with lime renderings, compatible.

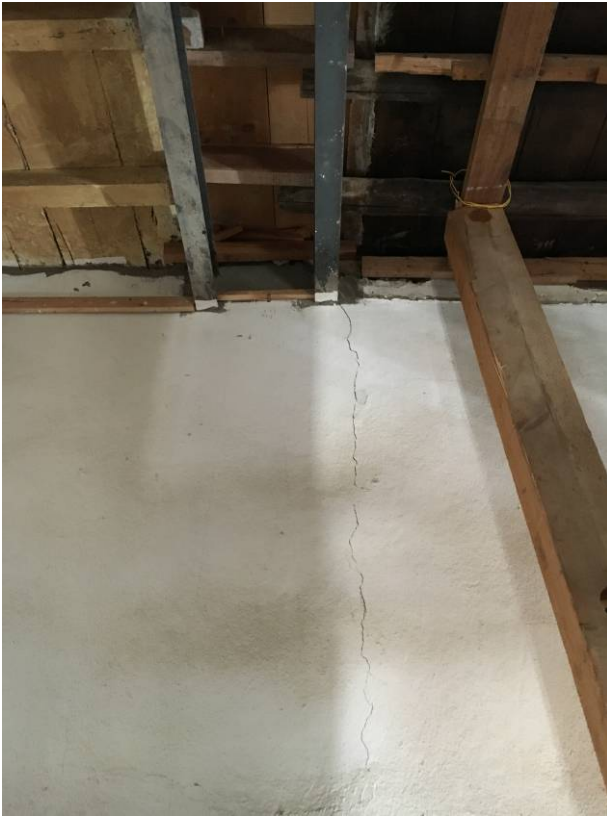
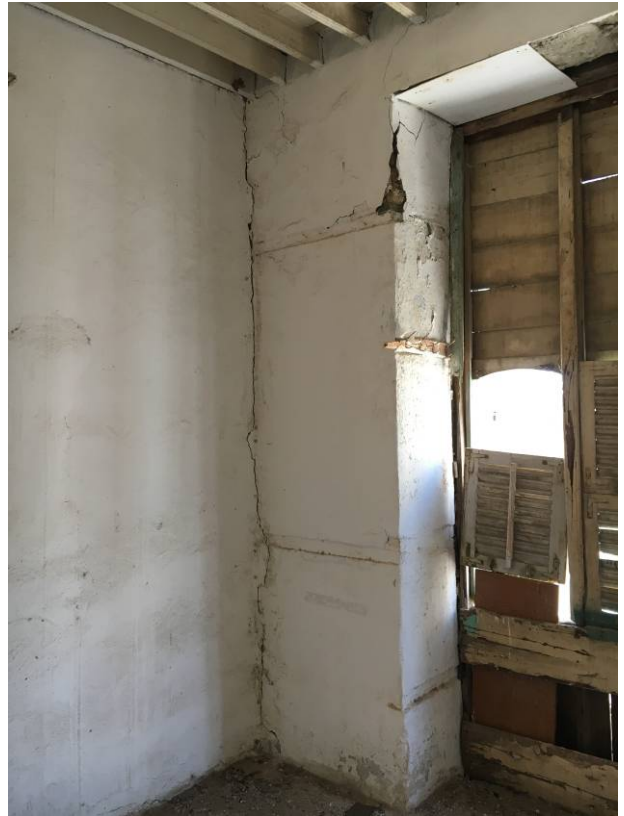
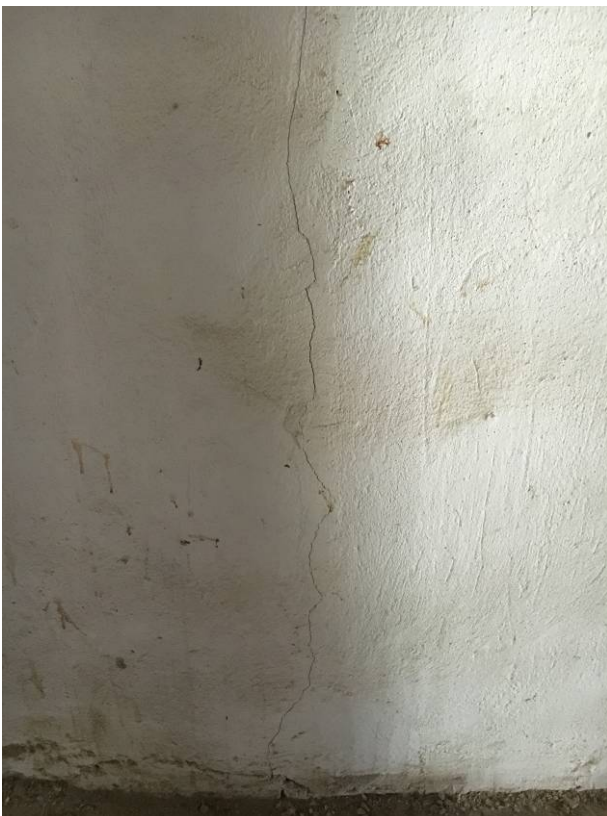
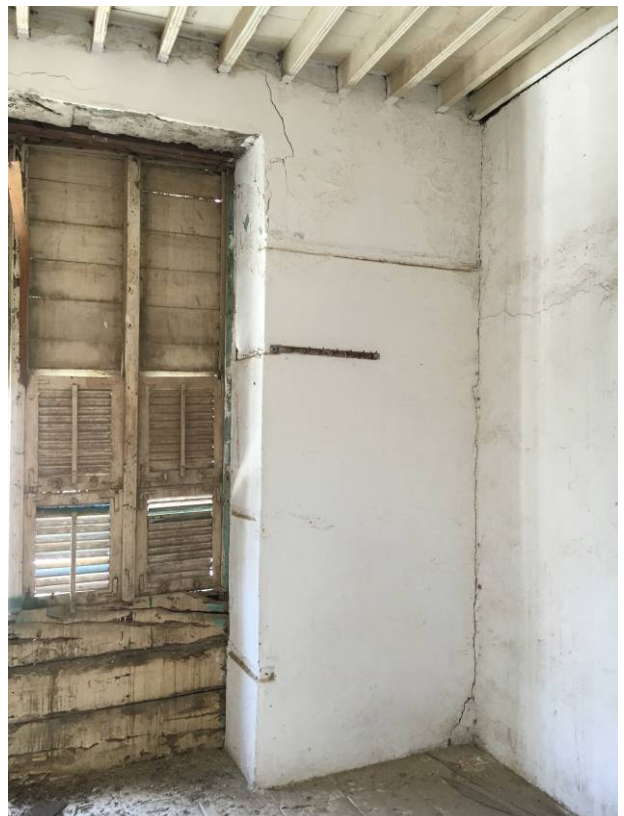
Vertical cracks (load, within plain wall)

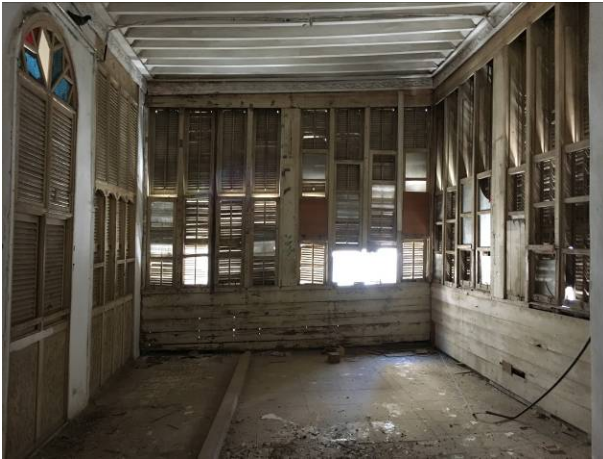
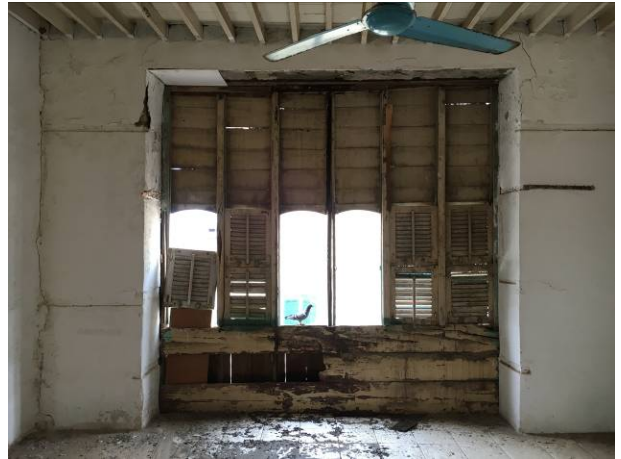
Wooden decoration, ceilings and roshans (inner views)

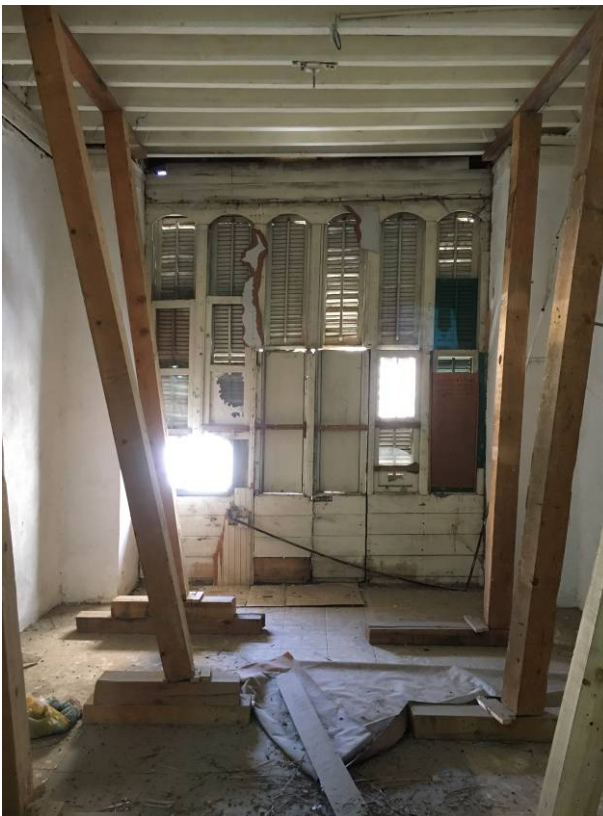
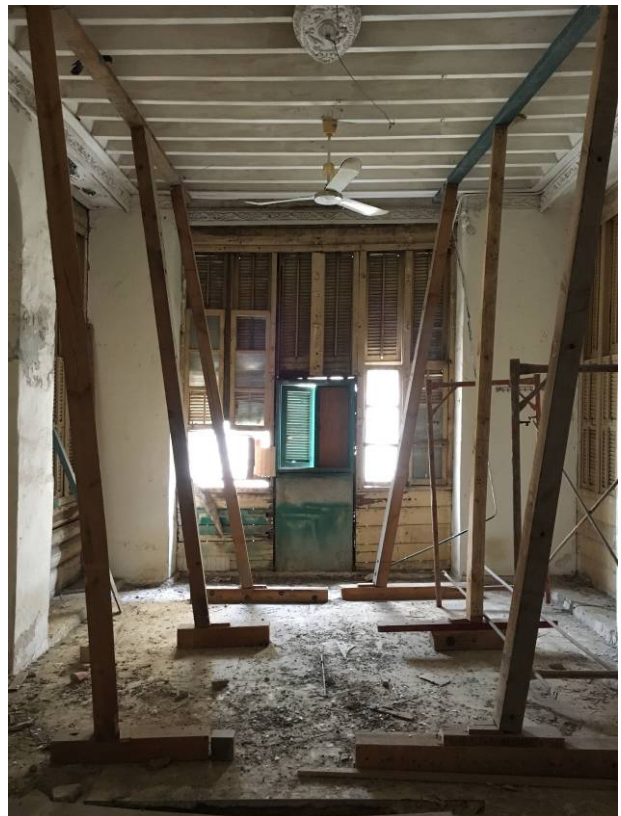
Wooden decoration, ceilings and roshans (inner views, with shoring) : some missing elements...

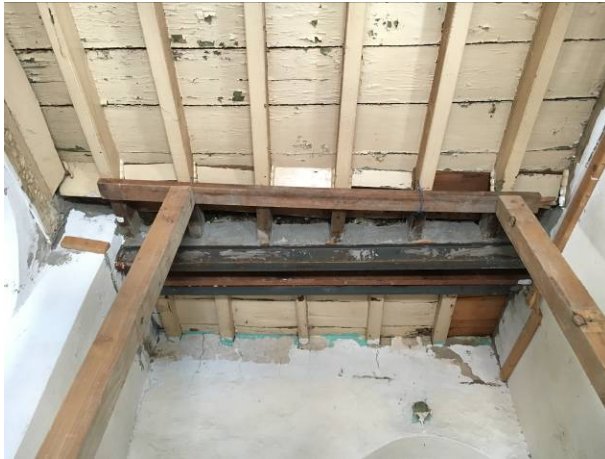
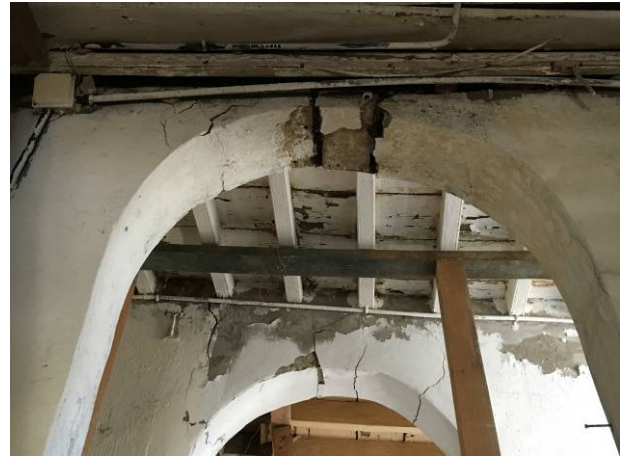
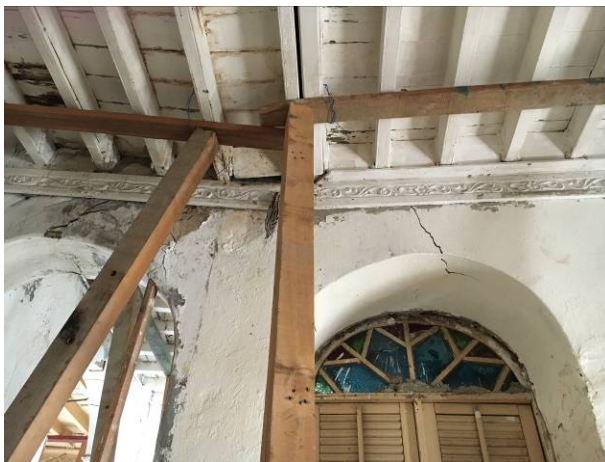
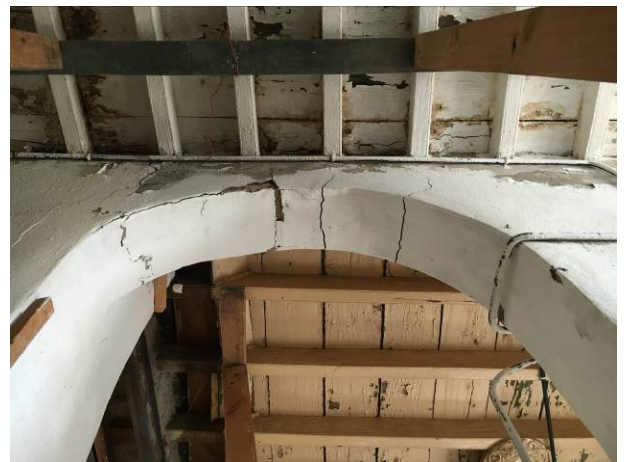
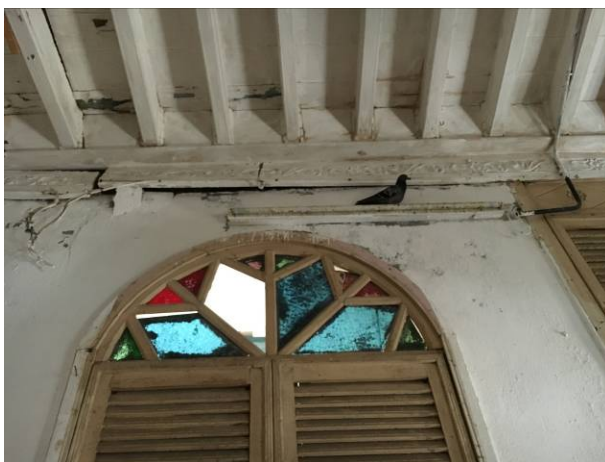
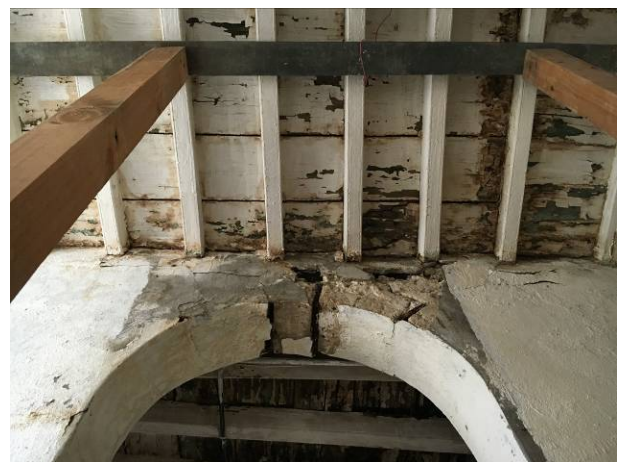
Wooden ceilings sagging; with cracks over some window arches. Wooden elements to repair, clean, and eventually replace...

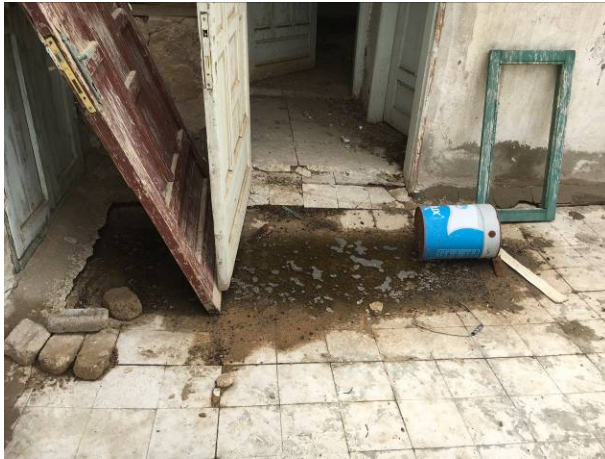
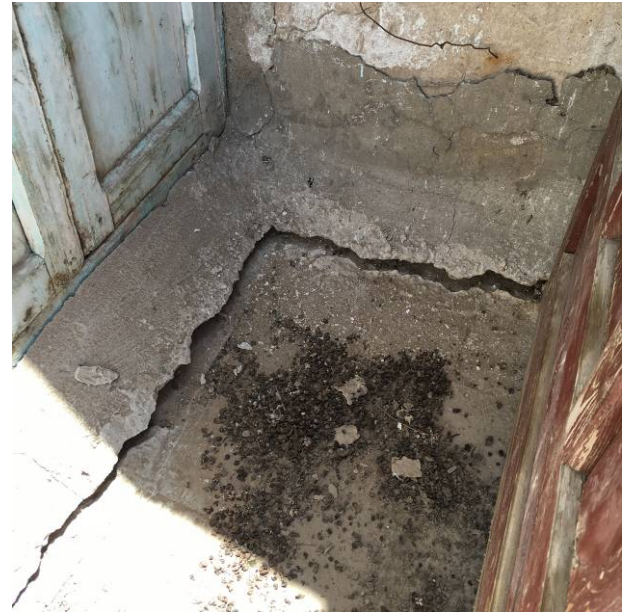
Most important and urgent pathology in the building : a shift in the slopes of the terrace led to water stagnation, water infiltration, cracks, sagging... After rain...

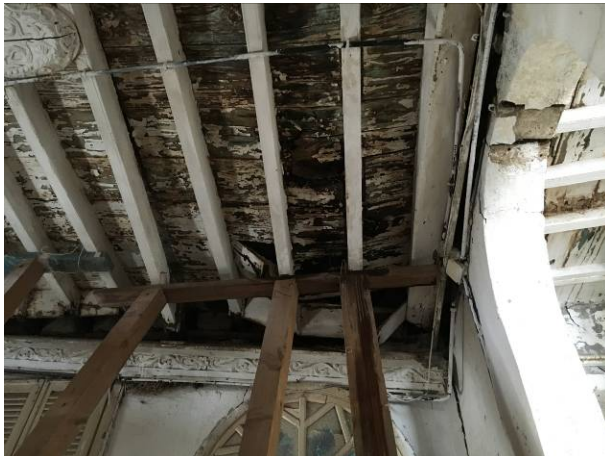
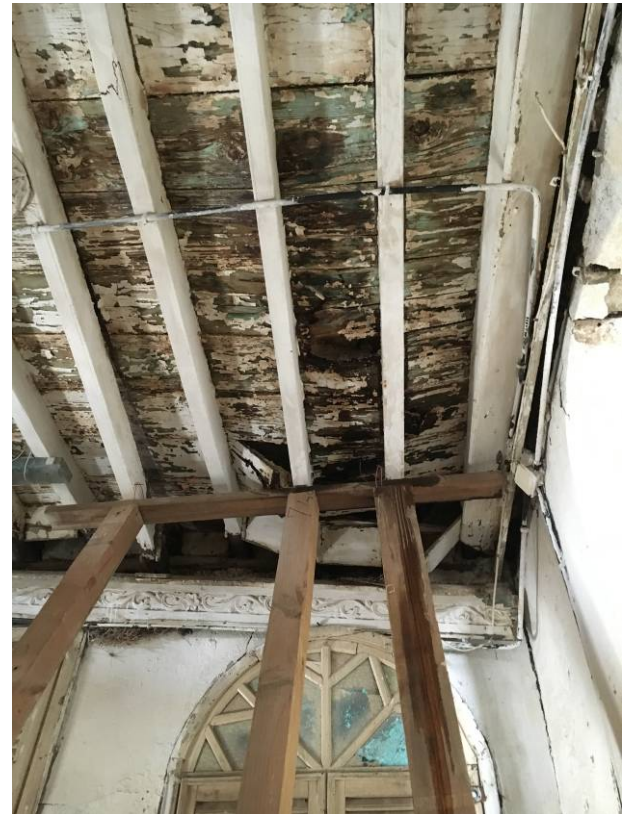
Damages on the ceiling below the water infiltration, with most wooden elements rotten, needing replacement, and damaged mortars (cf arch). For more safety, preventive shoring could be doubled here, parallel to existing one (one meter distance for ex.).

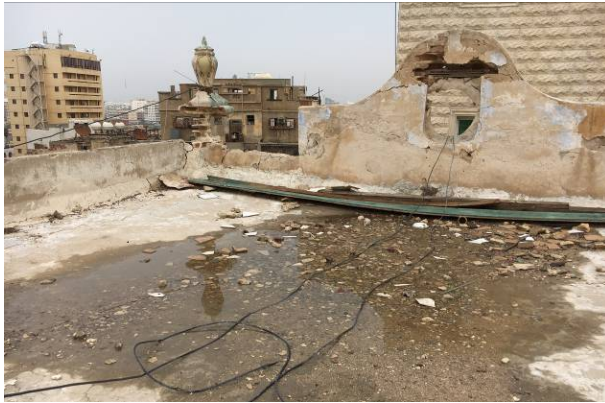
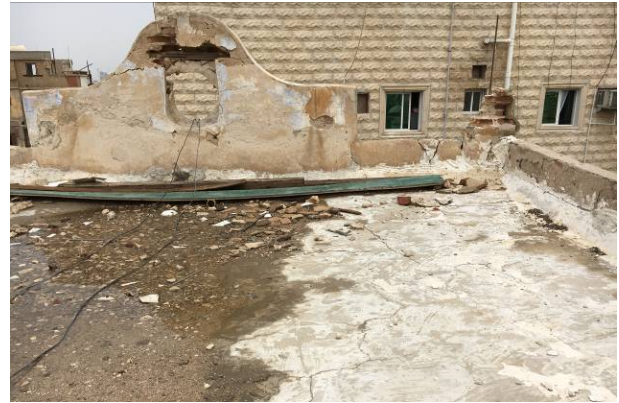
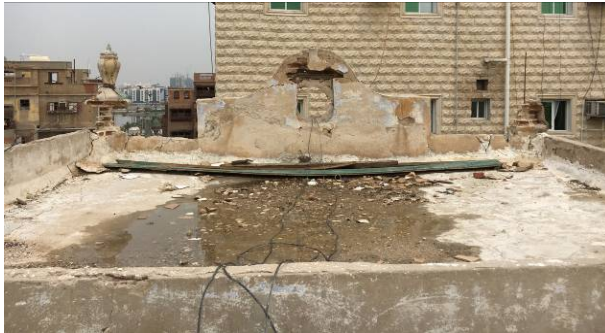
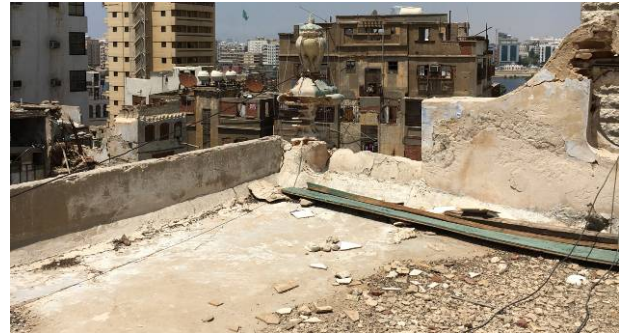
Roof slopes outward are not functioning and water is stagnating, damaging the surface and ultimately infiltrating the masonry, disrupting connections... Need for repair, and ideally the implementation of a connected floor, completed by the necessary protection/insulation layers...

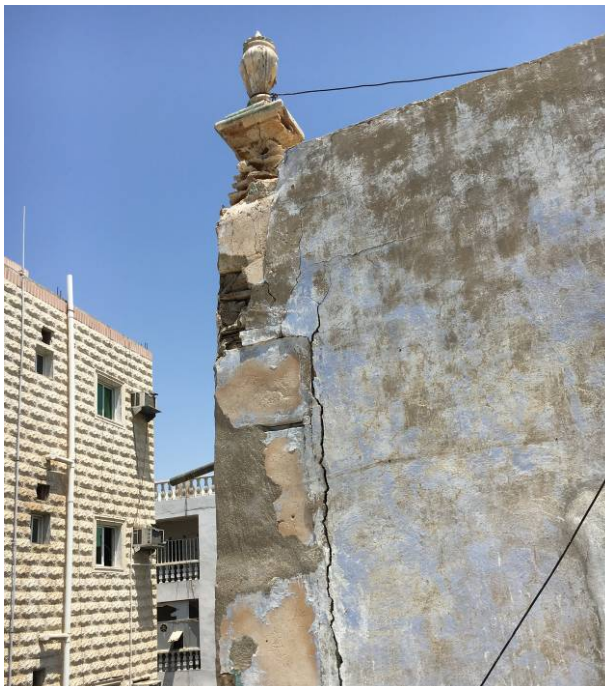
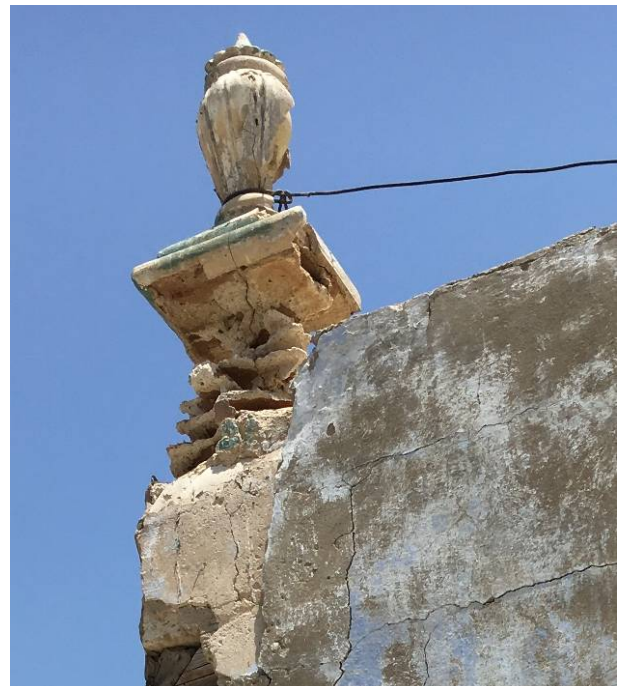
Decorative element hanging by a thread, needs removal and repair before being replaced after general consolidation works took place. Vertical crack on the left indicates movement of the wall outward and calls for connection to the floors and other walls (connected flooring).

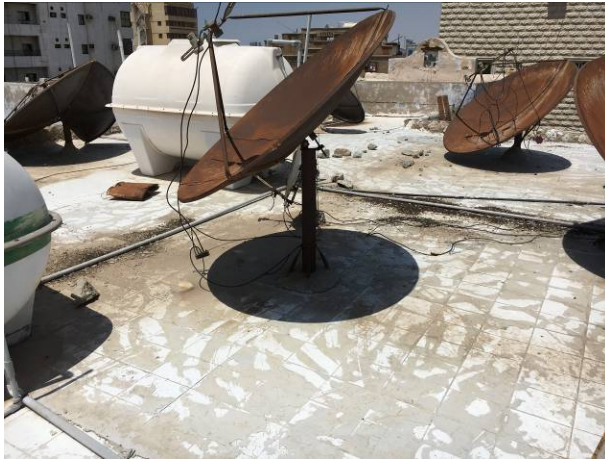
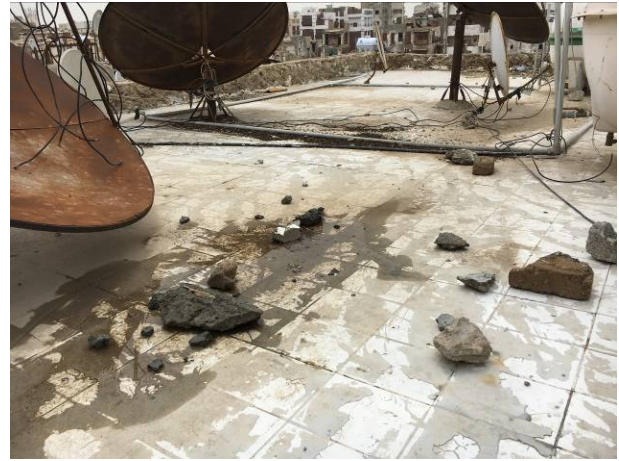
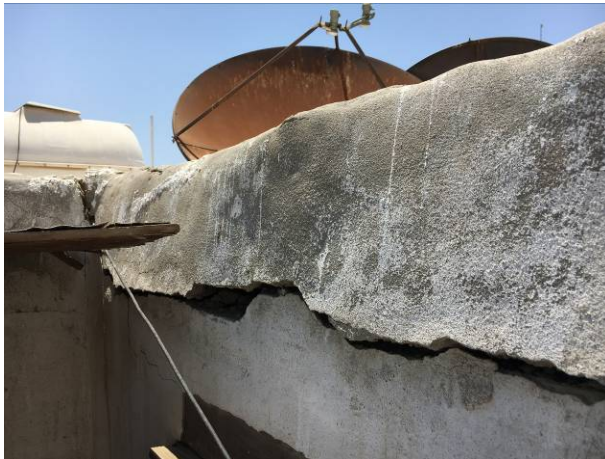
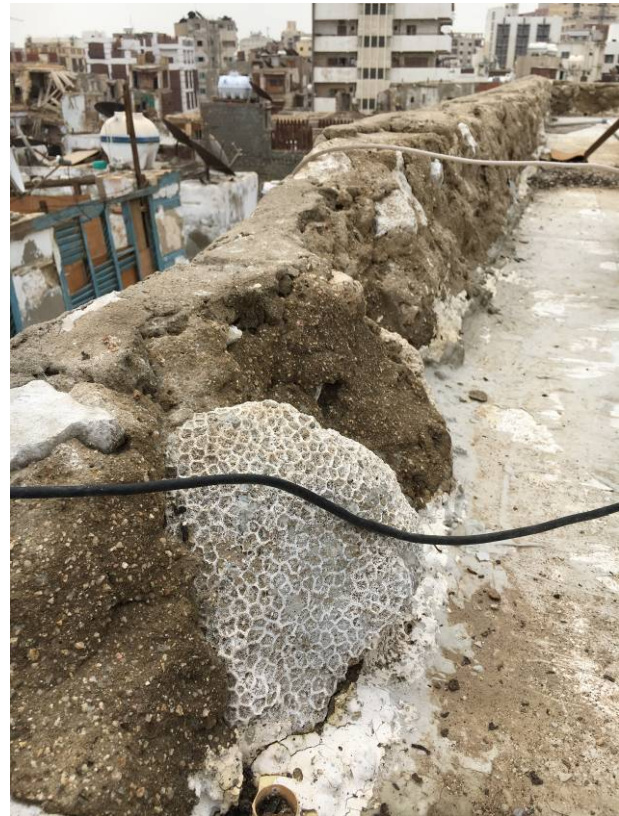
Roofing : parabolic antennas and cisterns to be removed, as well as cement layers on the acrotera parapets in coral stones, to be protected with lime mortar.

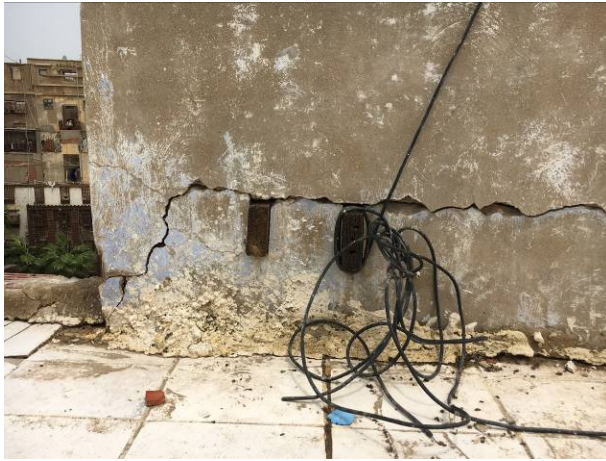
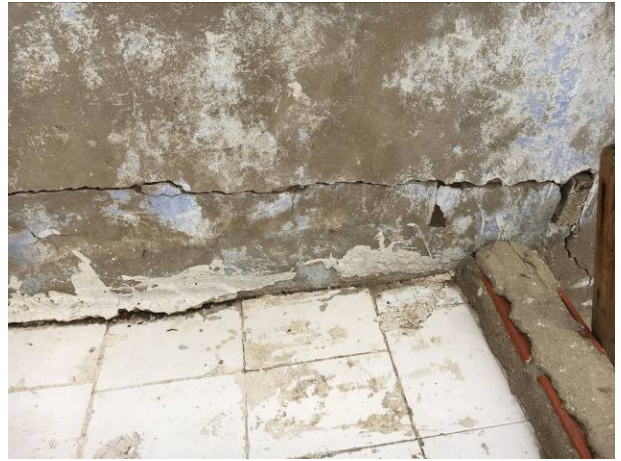
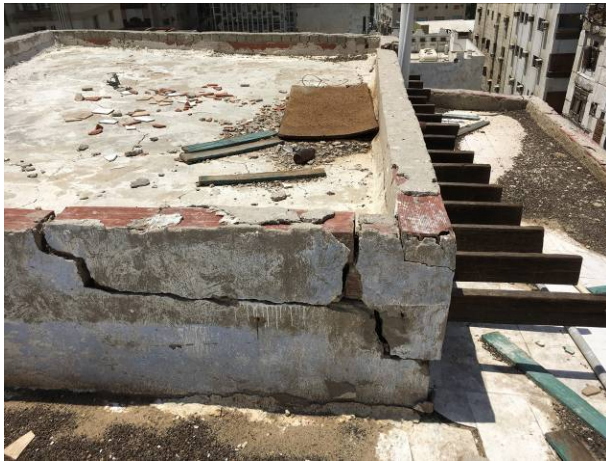
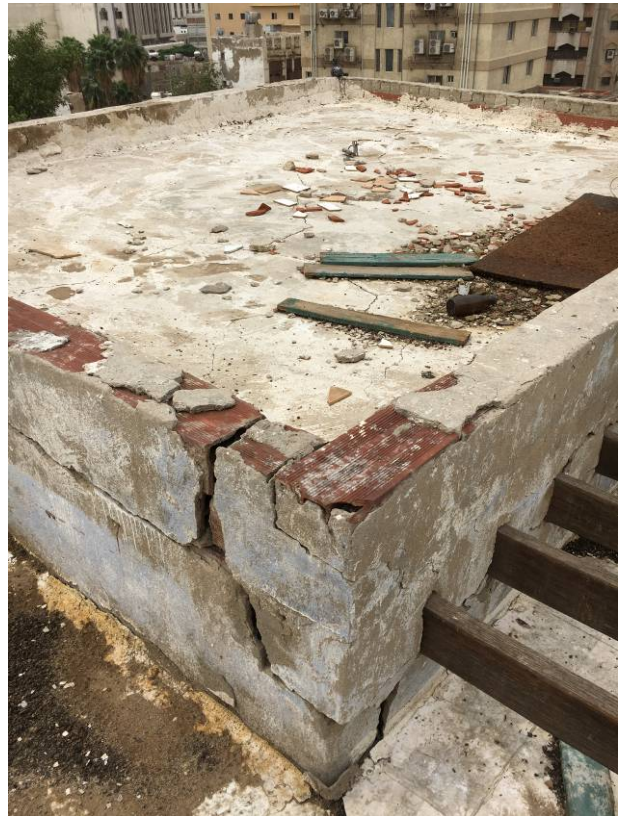
Roof terraces - Sagging and reversal of slopes led to water stagnation, infiltration, cracks. If nothing is done, this process will be resulting in the dismantling of masonry elements and floors, and ultimately the collapse of the building...

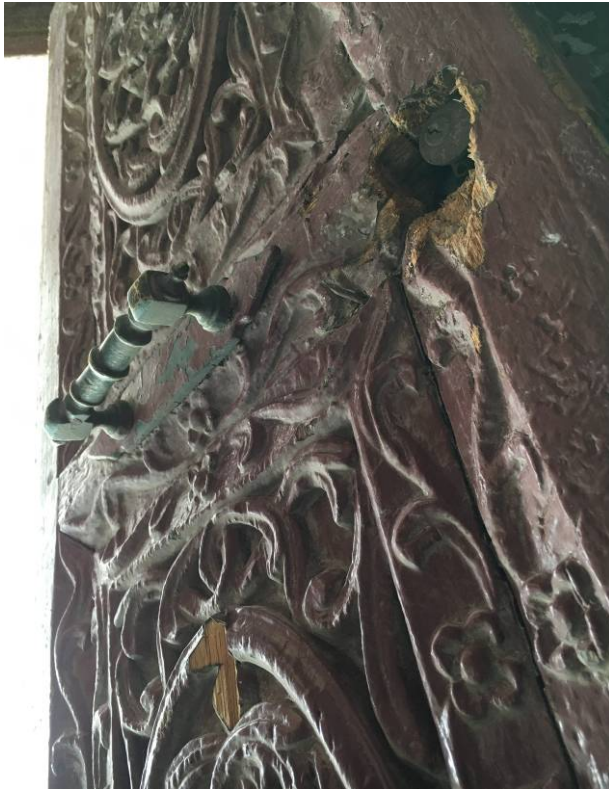
Refined sculptured wooden door, at the entrance: need for cleaning and repair, with the replacement of a few damaged elements...

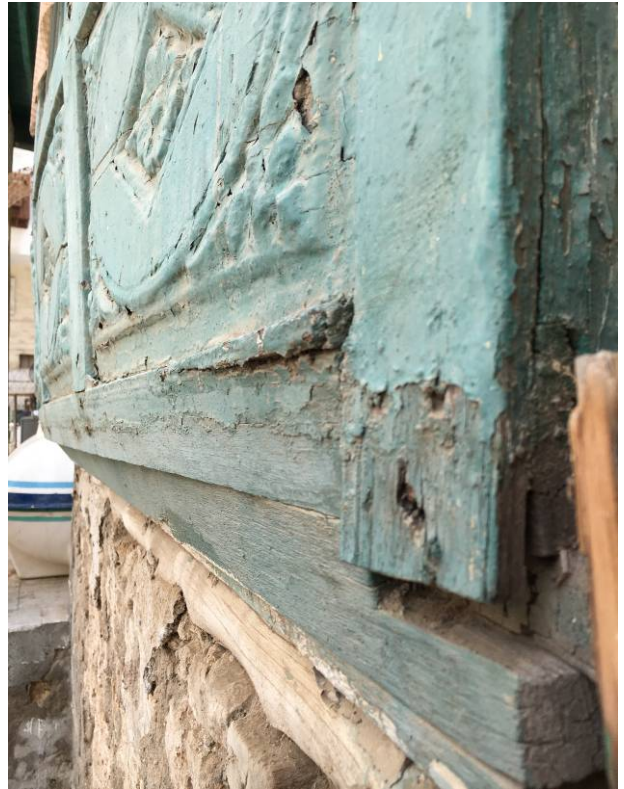
Wooden elements to be cleaned and repaired, with partial replacement.

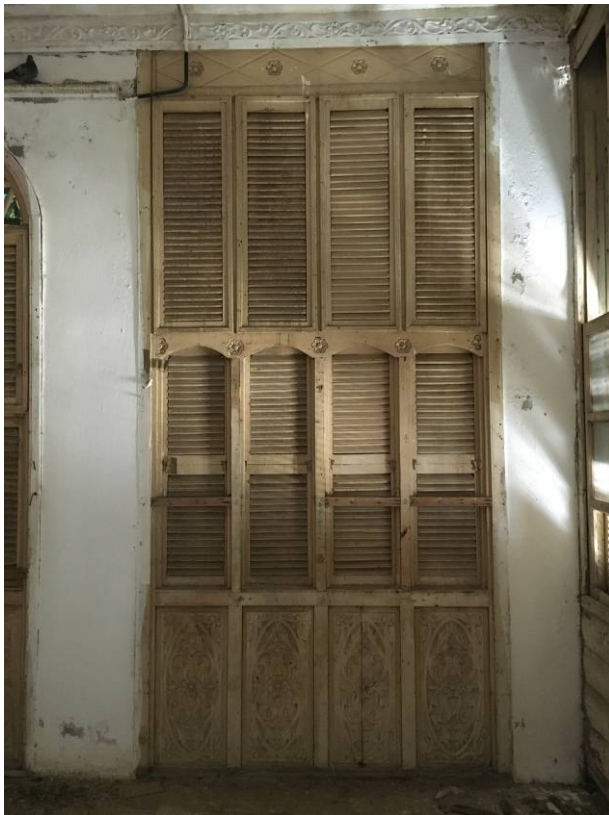
Wooden decorative elements in a relatively good state, needy cleaning and punctual replacements...

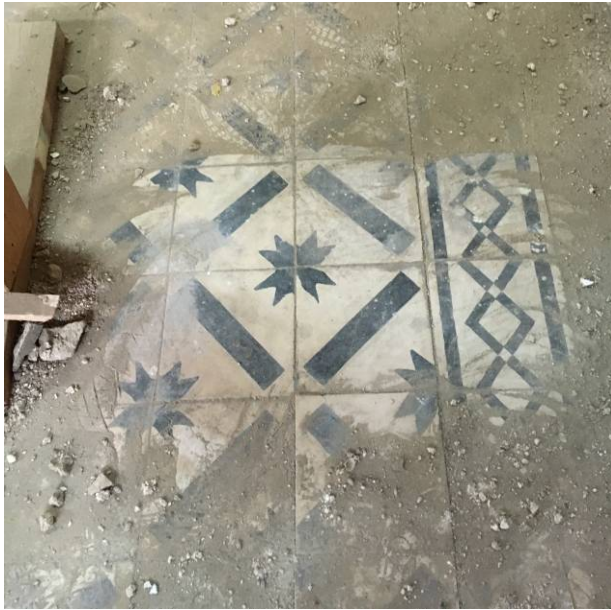
Decorative cement tiles (to recuperate, and put back on top of newly connected flooring)

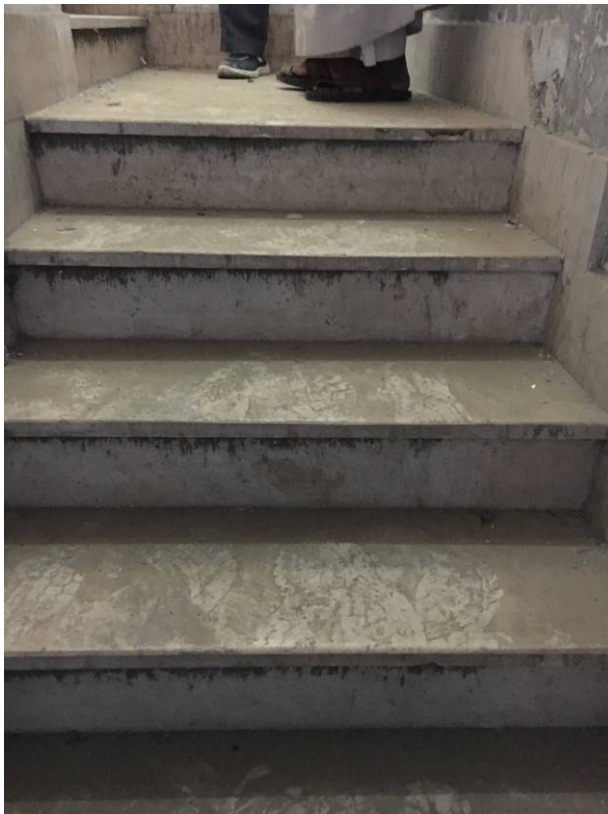
New staircase, to be cleaned and arranged ; no need for replacement, unless there is a will to put back into shape the original type of stairs (stone and mortar, with wooden edges)...

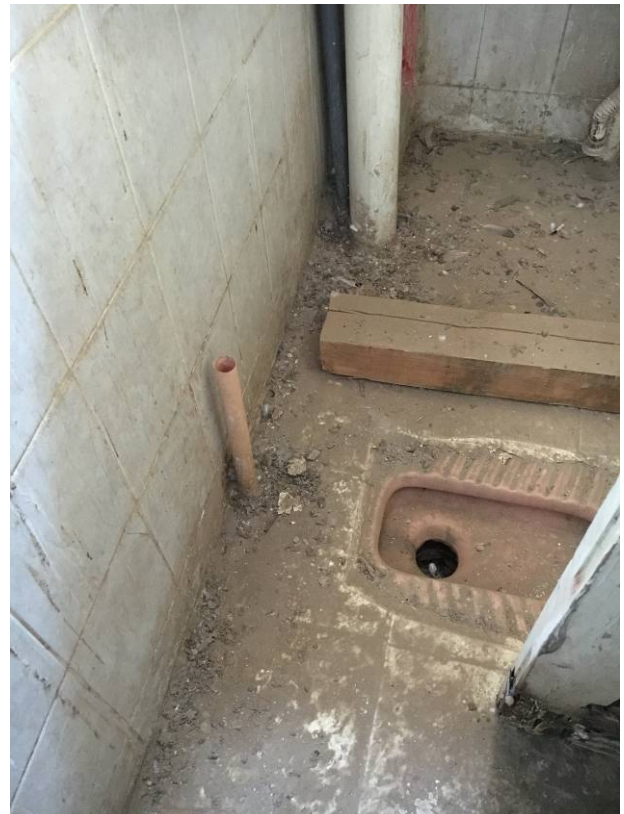
Modern bathrooms need to be cleaned up and reconfigured, according to the defined use and associated architectural project.
